## Geoelektrical Survey

### Calibration Measurement in the Josephi Tunnel

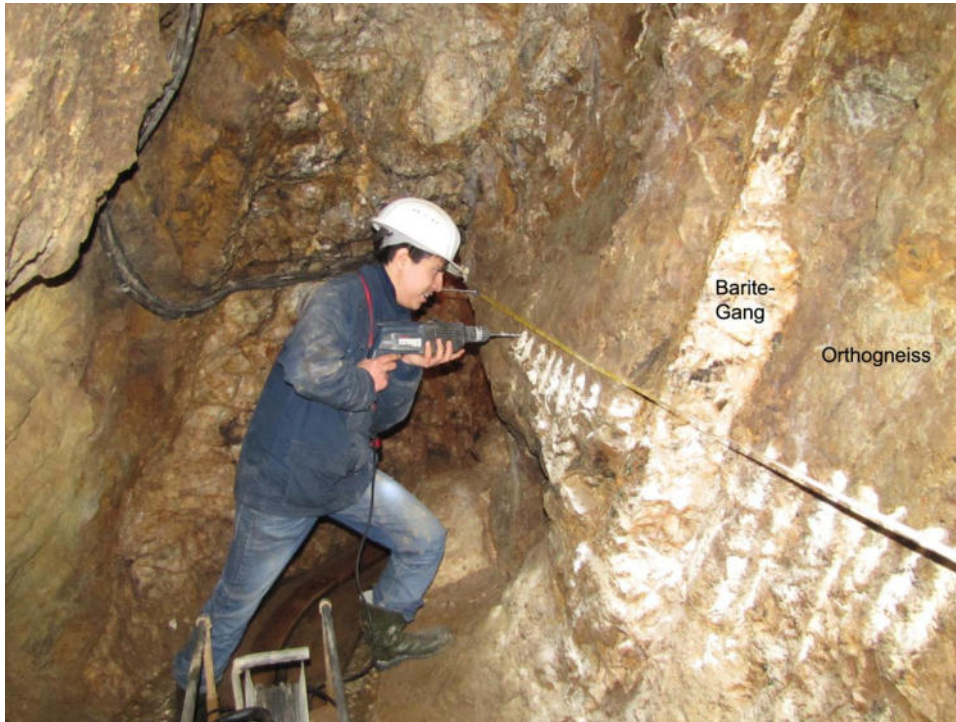
Drill holes for current electrodes; Jonathan (Moll)

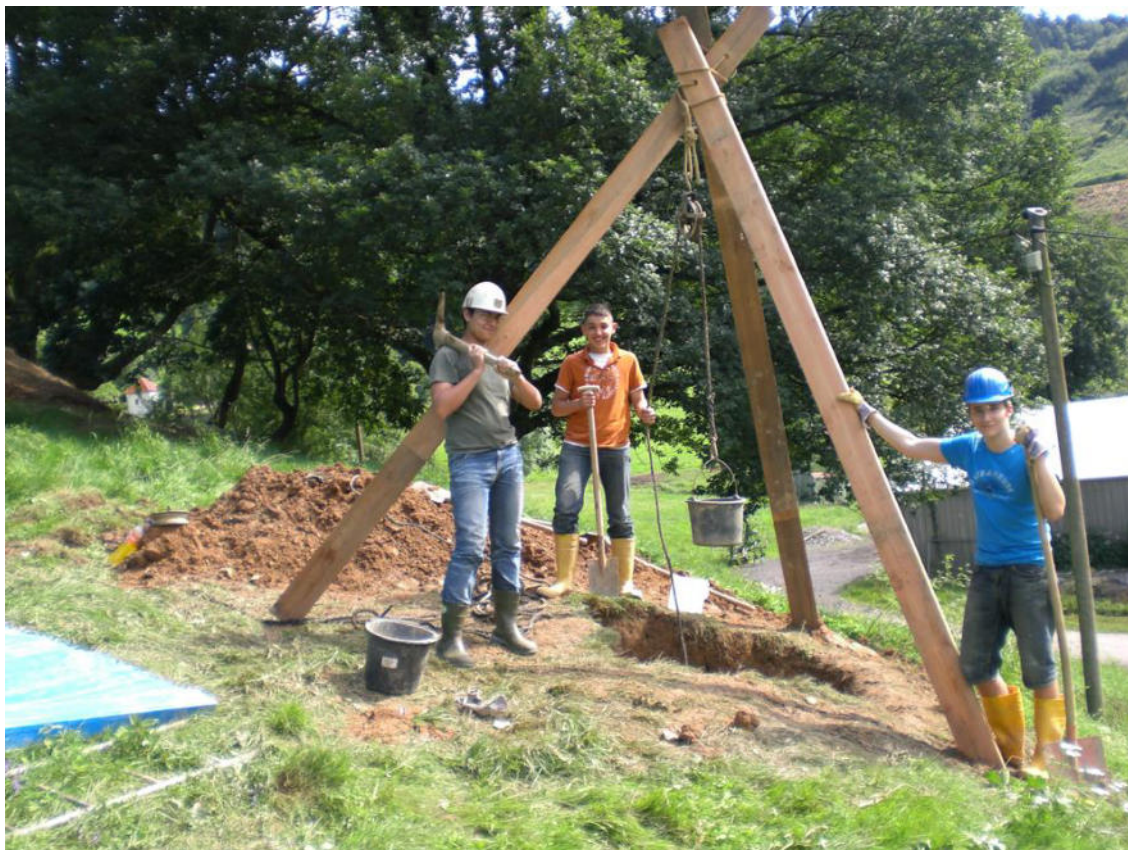
Test Pit: Jonathan, Alper, Jérôme; (Moll)

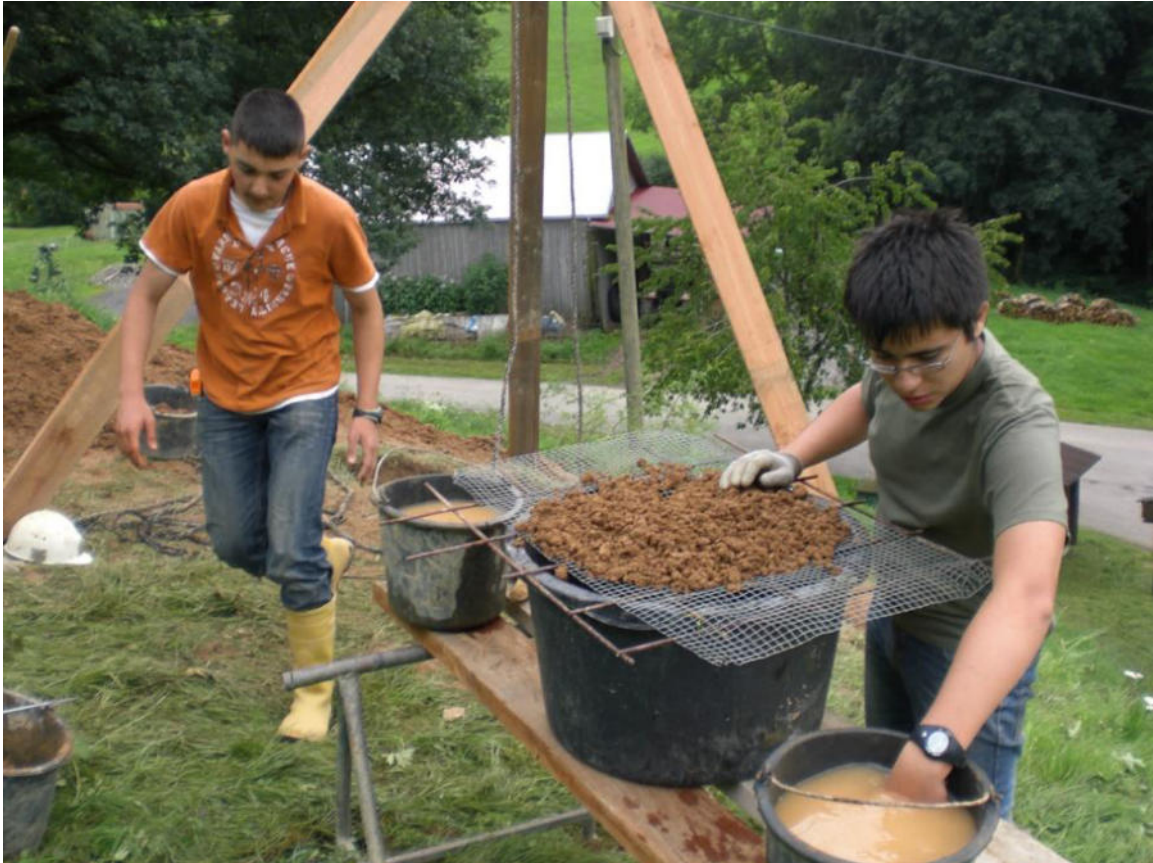
Sieving of excavated material from 180 m depth; Alper, Jonathan; (Moll)

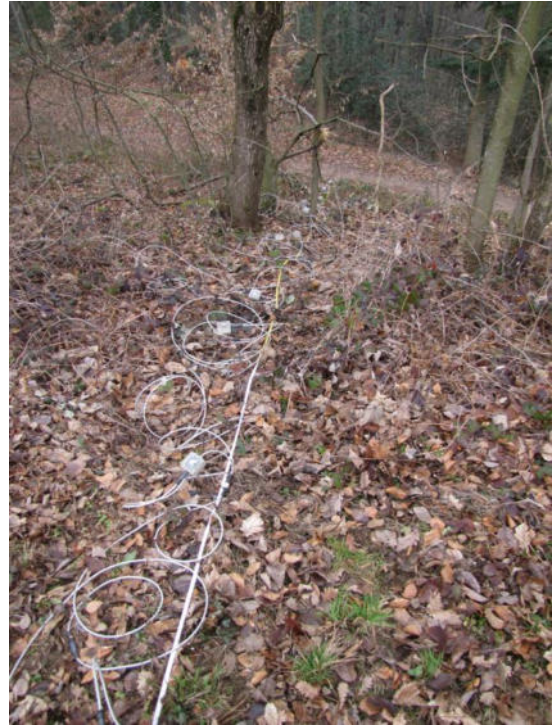
The local orientation of this survey was based on assumptions by current miners that the old Anna Vein might be located in this section. This vein is mentioned in historical records but has not yet been found. The present measurement was therefore conducted to search for this historic vein.
